INSPECTION REPORT

For the Property at:
11625 LAND CT
LAKE COUNTRY, BC

Prepared for: HELENE BARTON
Inspection Date: Thursday, December 9, 2010
Prepared by: Tim Walker

Report No. 1023

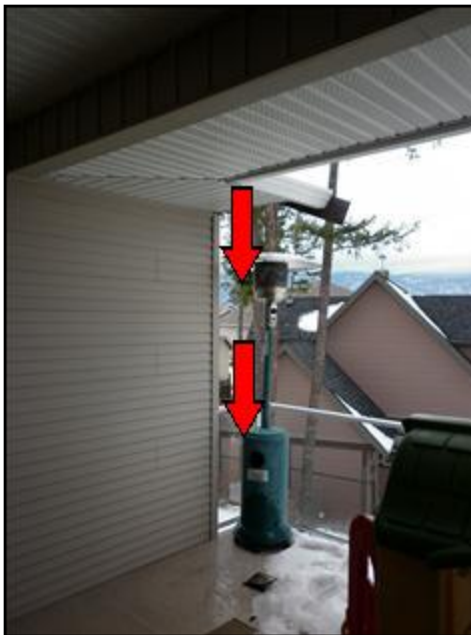
2.

1. Condition: • [Leak](#)

Implication(s): Chance of water damage to contents, finishes and/or structure

Location: Rear Middle Balcony

Task: Repair

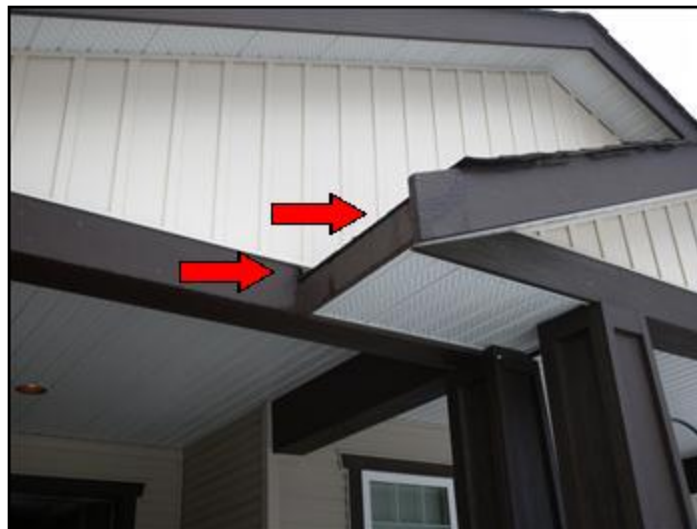
3.

2. Condition: • [Missing](#)

Water is draining from this roof down onto steps at main front door entry. In warm weather this is annoying, however in freezing temperatures this may produce a dangerous stepping environment. Snow may melt in the day time, drip below onto step, then freeze overnight producing ice on the steps. Installation of gutter and downspout here is recommended. Incidentally the roofing on this edge is not overhanging the fascia sufficiently to protect it. Increase overhang of shingles here to 1" minimum and also protect the extended fascias with roofing material to insure longer life to the fascias and prevention of rot.

Implication(s): Chance of water damage to contents, finishes and/or structure

Location: Porch

Task: Provide

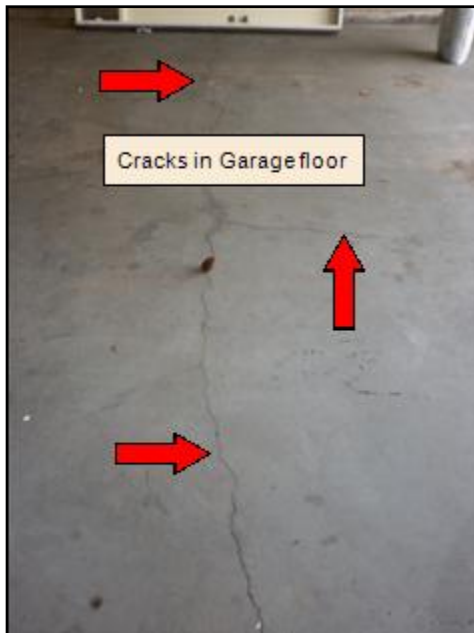
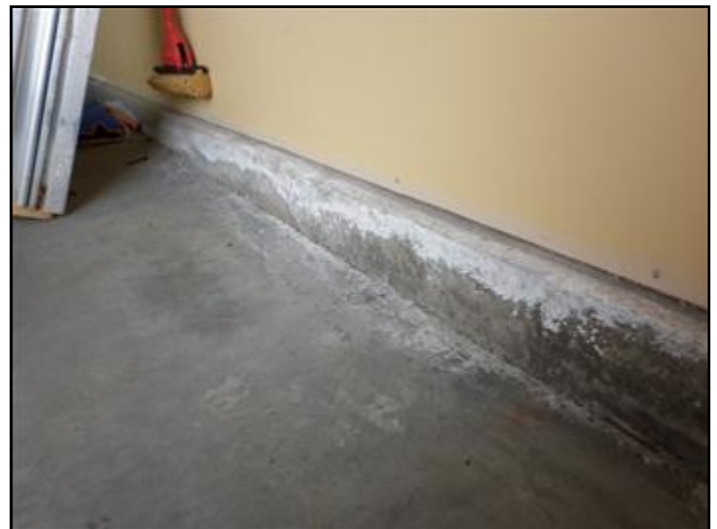
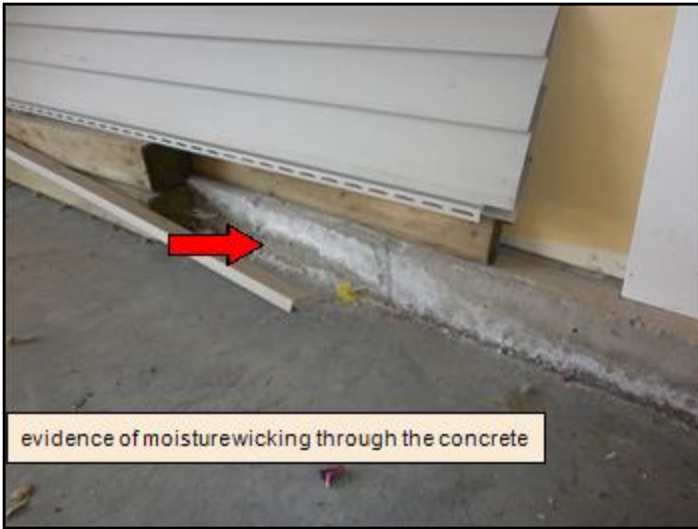
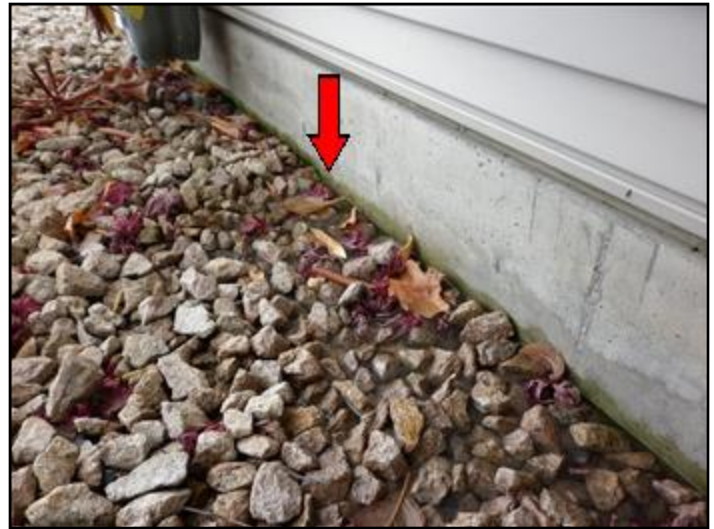
3. Condition: • [Downspouts discharging below grade](#)

Standing water was noted outside the garage wall, next to the gas meter. The source of this water was not determined. Underground drains for the roof downspout is suspect. Further evaluation of this water source is recommended immediately. Failure to eliminate this water from the foundation wall area could result in frost heaving, or breaking of the concrete foundation wall, and or the garage floor slab. There was some cracking noted in garage floor which could be caused by this water.

Implication(s): Chance of water damage to contents, finishes and/or structure

Location: Exterior wall

Task: Further evaluation

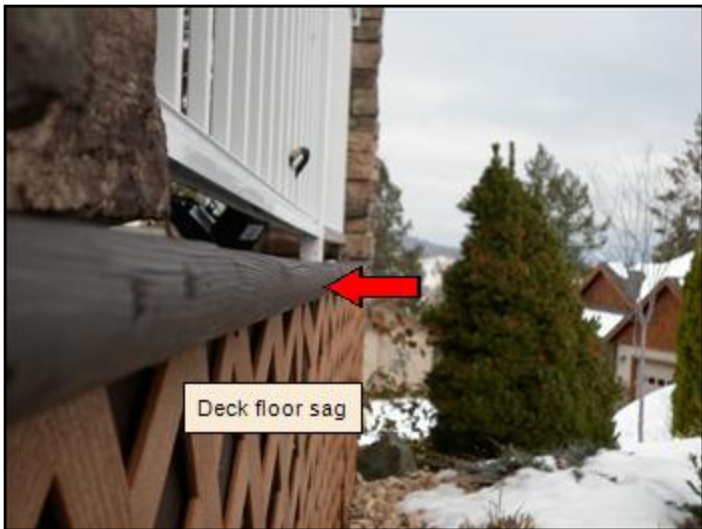
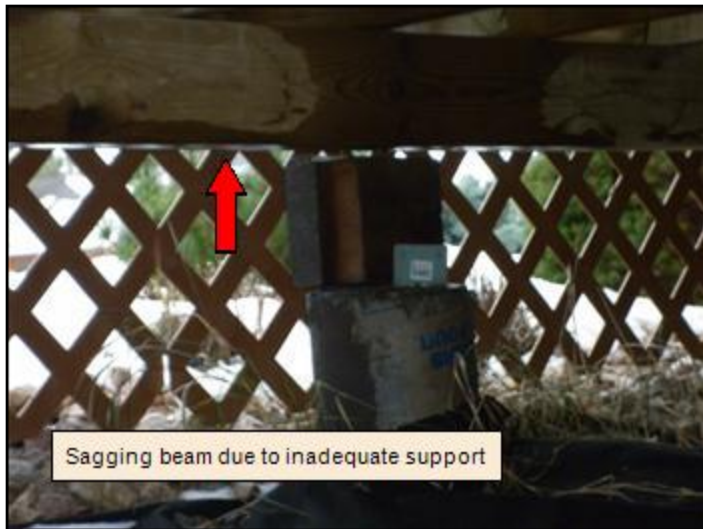
4. Condition: • [Sag](#)

Implication(s): Weakened structure | Chance of movement

Location: Front Porch

Task: Correct

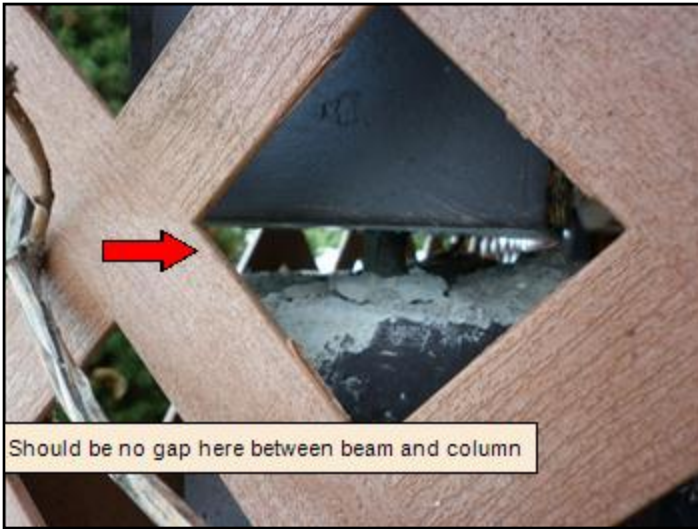
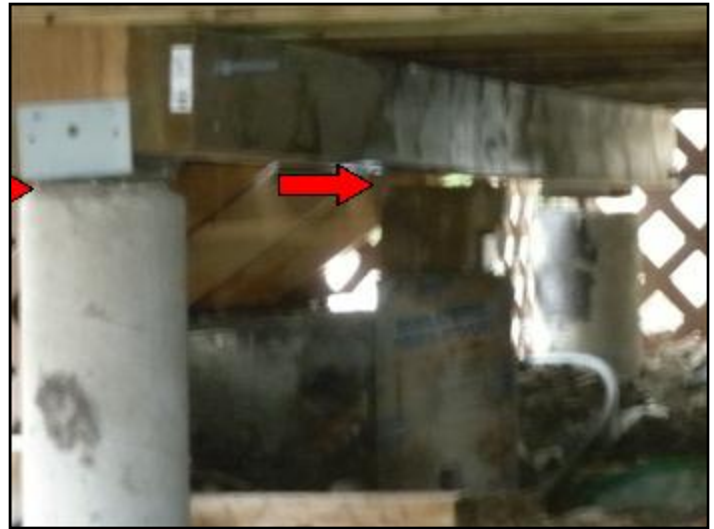
5. Condition: • [End support inadequate](#)

Implication(s): Weakened structure | Chance of movement

Location: Front Porch

Task: Correct

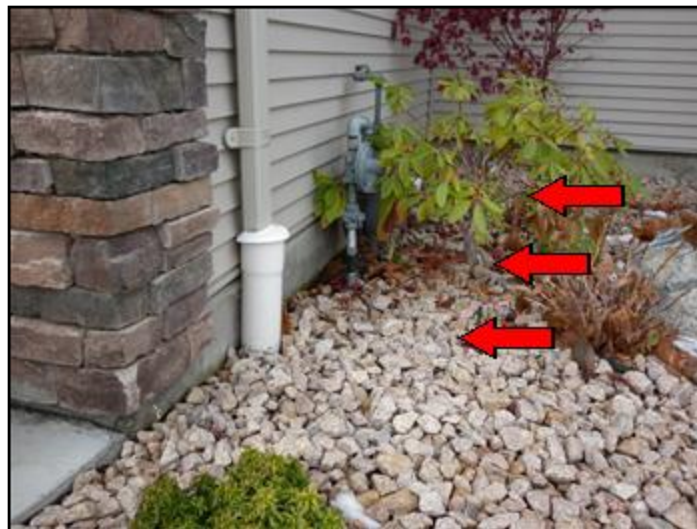
12.

6. Condition: • [Improper slope](#)

The ground slopes slightly toward the house here. Coupled together with a water source (which appears to be the underground drain for the downspout) this allows water to collect against the building. Water causes many problems in buildings and should not be allowed to collect here. Resloping the ground away from the house is recommended here. Freezing temperatures with this kind of moisture could cause heaving and breaking of concrete foundation.

Implication(s): Chance of water damage to contents, finishes and/or structure

Location: Garage

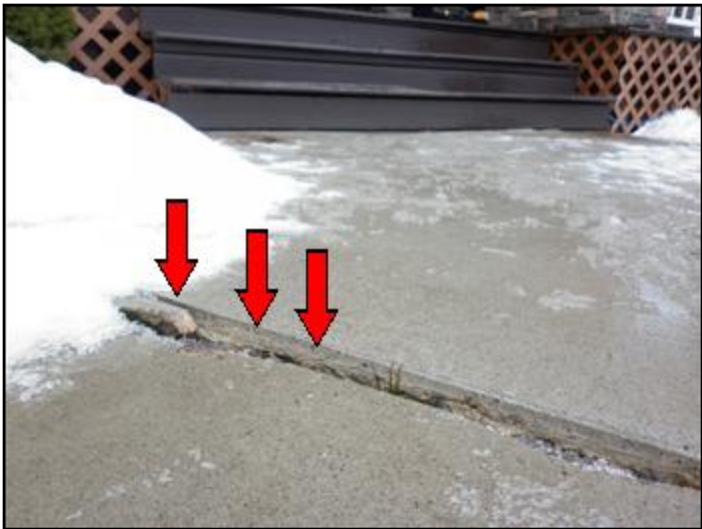
13.

7. Condition: • [Uneven \(trip hazard\)](#)

Implication(s): Physical injury

Location: Front Yard

Task: Correct

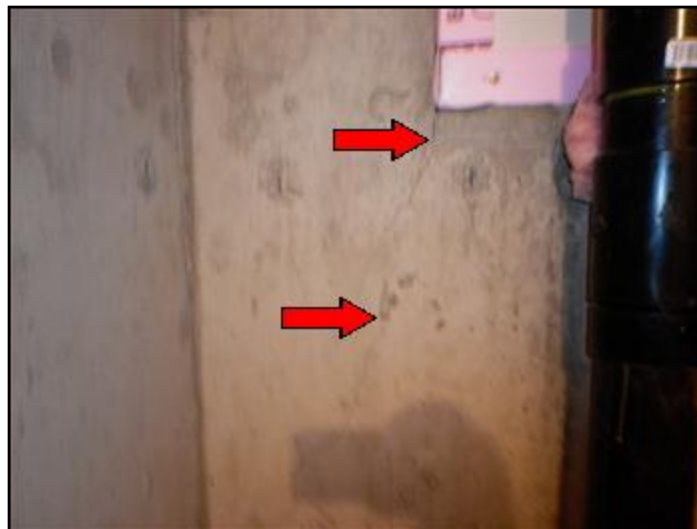
14.

8. Condition: • Typical minor cracks

Location: Basement

Task: Monitor

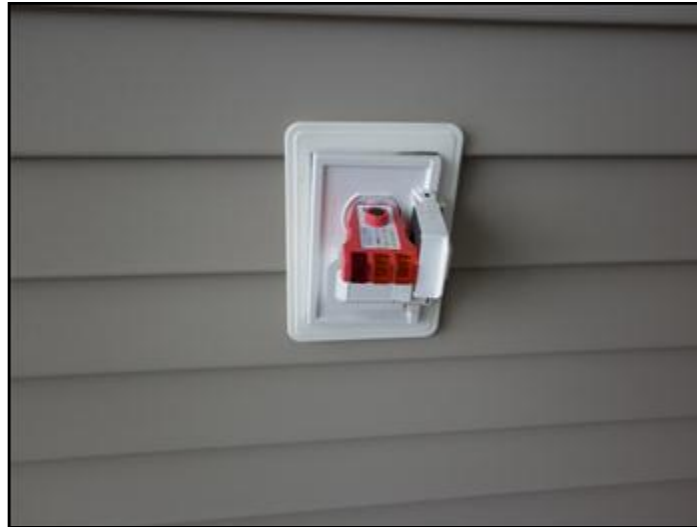
16.

9. Condition: • [Inoperative](#)

No power was observed at these two exterior outlets. It is possible they are switched, or more likely linked to a GFCI which has tripped. Neither switch, nor GFCI breaker was located during inspection. Further evaluation by a qualified electrician is recommended. Implication: No power available on rear deck.

Implication(s): Equipment inoperative

Location: Rear Exterior Balcony

Task: Further evaluation

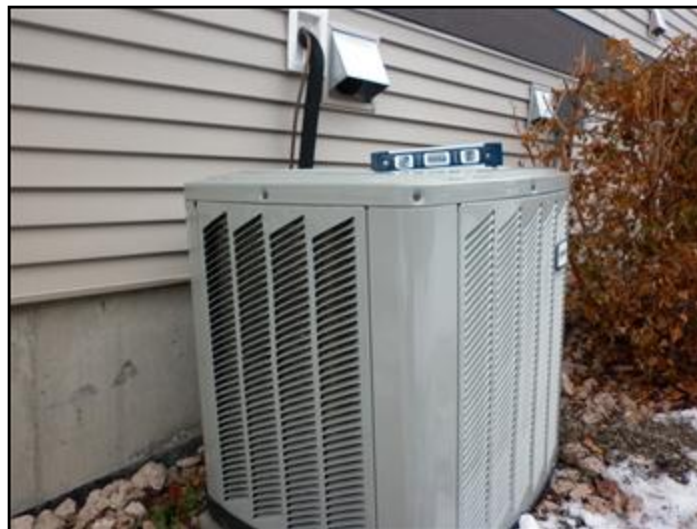
18.

11. Condition: • [Out of level](#)

Implication(s): Reduced system life expectancy | Damage to equipment

Location: Exterior Wall

Condensing unit out of level

Task: Correct

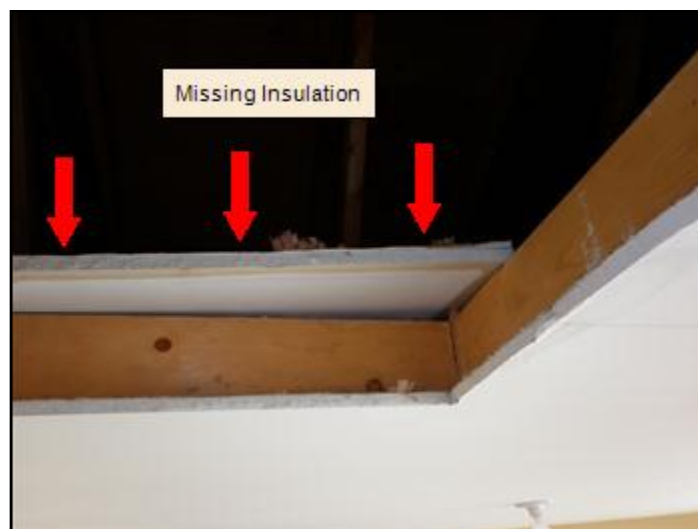
19.

13. Condition: • [Not insulated and not weatherstripped](#)

The attic area above the garage is insulated with 4" (R-12) Fiber Glass insulation. The hatch is not, nor is the garage door. If heat is added to garage space, insulating this hatch is recommended at that time.

Implication(s): Chance of condensation damage to finishes and/or structure | Increased heating and cooling costs | Reduced comfort

Location: Garage

Task: Improve

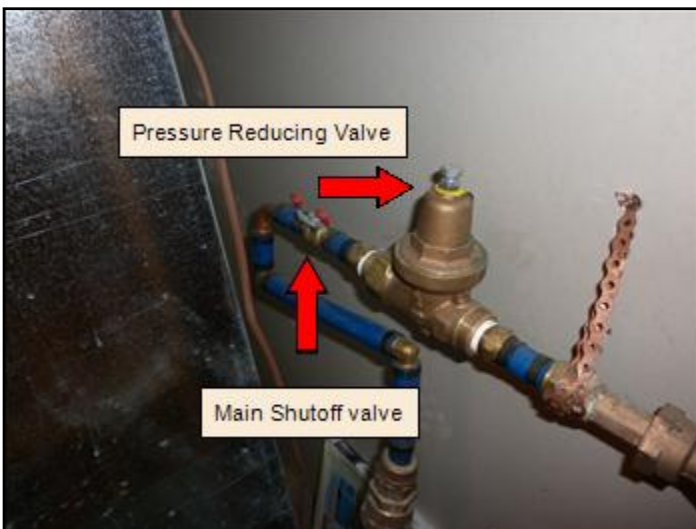
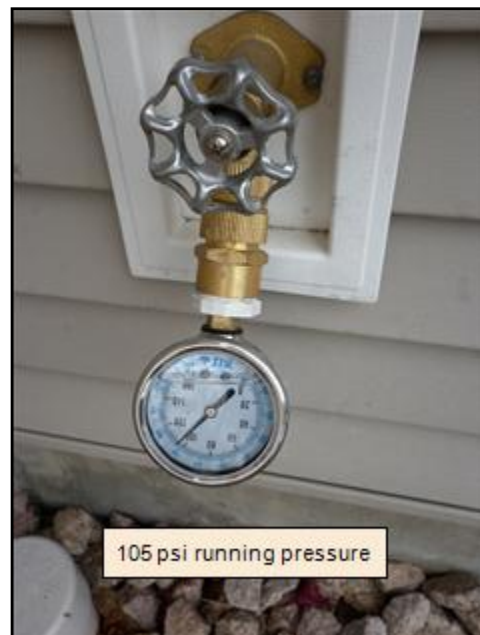
14. Condition: • The static psi (when all the water is turned off in the house) is 110 psi, and the running psi (the pressure remaining in the pipes with water running) is 105 psi. These are too high. Appliances and plumbing fixtures like to see between 60-80 psi. The pressure reducing valve is located in the utility room, right down stream of the main water shutoff for the house. This has a bolt on top. The pressure reducing valve may be set too high, or it may be faulty. Further evaluation and correction of this is recommended.

Implication(s): Leaks and flooding in house

Task: Correct

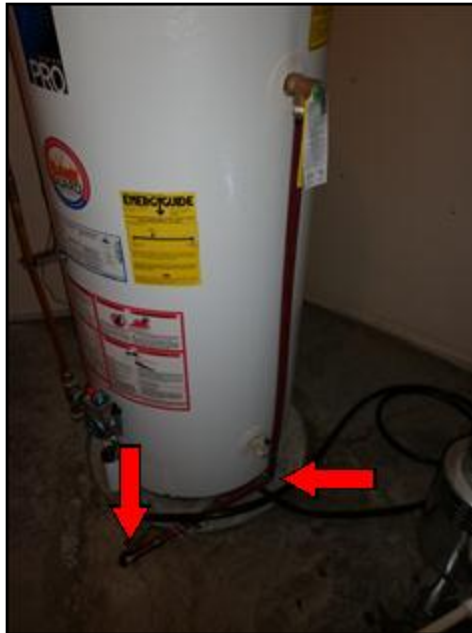
25.

15. Condition: • Modified TPR valve discharge tube. Adding elbows and extending the length of the discharge tube is not recommended to provide adequate free flow in the event of the TPR valve discharging. Terminating the tube 3 to 6 inches above the floor, and eliminating elbows from the tube is recommended.

Implication(s): Increased chance of scalding or injury

Location: Utility Room

Task: Correct

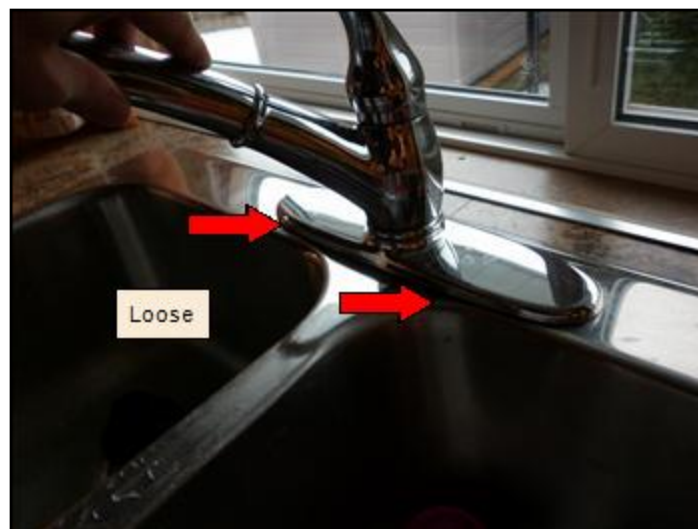
26.

16. Condition: • [Loose](#)

Implication(s): Chance of water damage to contents, finishes and/or structure | Damage or physical injury due to falling materials | Sewage entering the house

Location: First Floor Kitchen

Task: Correct

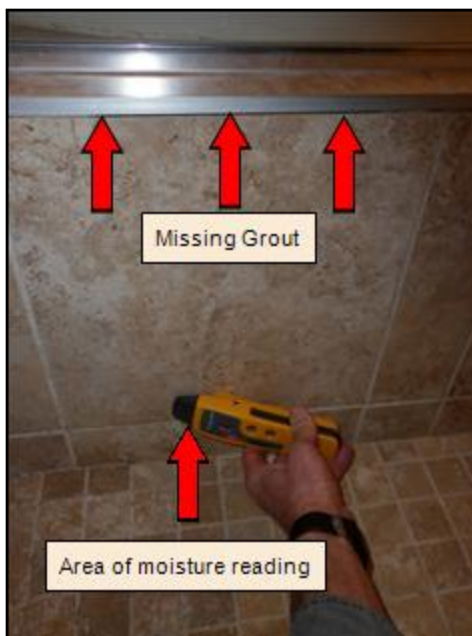
27.

17. Condition: • [Grout loose, missing or deteriorated](#)

Moisture readings were slightly high in the area only. Grout is missing in tile. Regrouting in this area is recommended. Also re sealing of the grout through out the shower stall is recommended. Further moisture testing is recommended three months following the repairs to verify moisture is gone. If moisture persists, retiling the shower stall may be necessary. If regrouting and sealing only is required the associated costs will be minimal. However if re tiling is required the costs will understandably be more substantial.

Implication(s): Chance of water damage to contents, finishes and/or structure

Location: Master Bathroom

Task: Correct and monitor.
